Soft Rot in Utility Poles Salt-treated in the Years 1940–1954

1. Microbiological, microscopic and chemical studies of some salt-treated utility poles installed in Sweden in the years 1941–1946.

2. Mechanical properties of soft rot decayed Scots Pine with special reference to wooden poles.

3. Studies and experiences of occurrence and development of soft rot in salt-treated poles of pine (*Pinus silvestris*) installed in Swedish transmission-lines in the years 1940–1954.

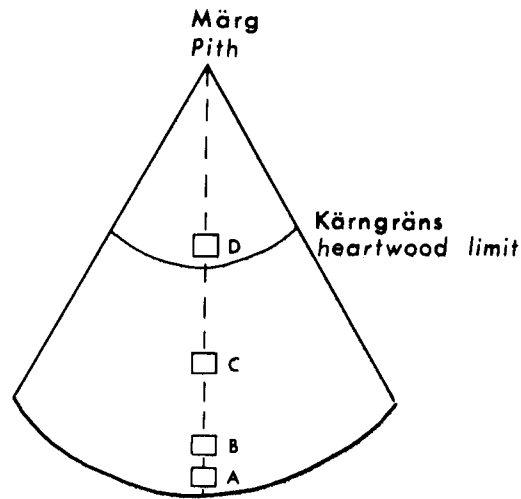
Fig 6. For the microscopic studies four samples were taken from each quadrant on the following positions: 5 (A) and 15 (B) mm from the periphery respectively, and half the distance between position (B) and the heartwood limit (C) and finally, approximately 5 mm inside the heartwood limit (D).

For the microscopic study samples were taken from four positions along the radius of the quadrant (See fig 6). The sampling positions were located on the following approximate distances from the periphery: A) 5 mm. B) 15 mm, C) half way between B and the heartwood limit and D) 5 mm inside the heartwood limit. The samples were examined with a light microscope in nonpolarized as well as in polarized light. Both earlywood cells and latewood cells were thereby studied in cross-section. Regarding the latewood cells, the soft rot attack was divided into five classes in which the number of cavities at a certain site was used as a criterion:

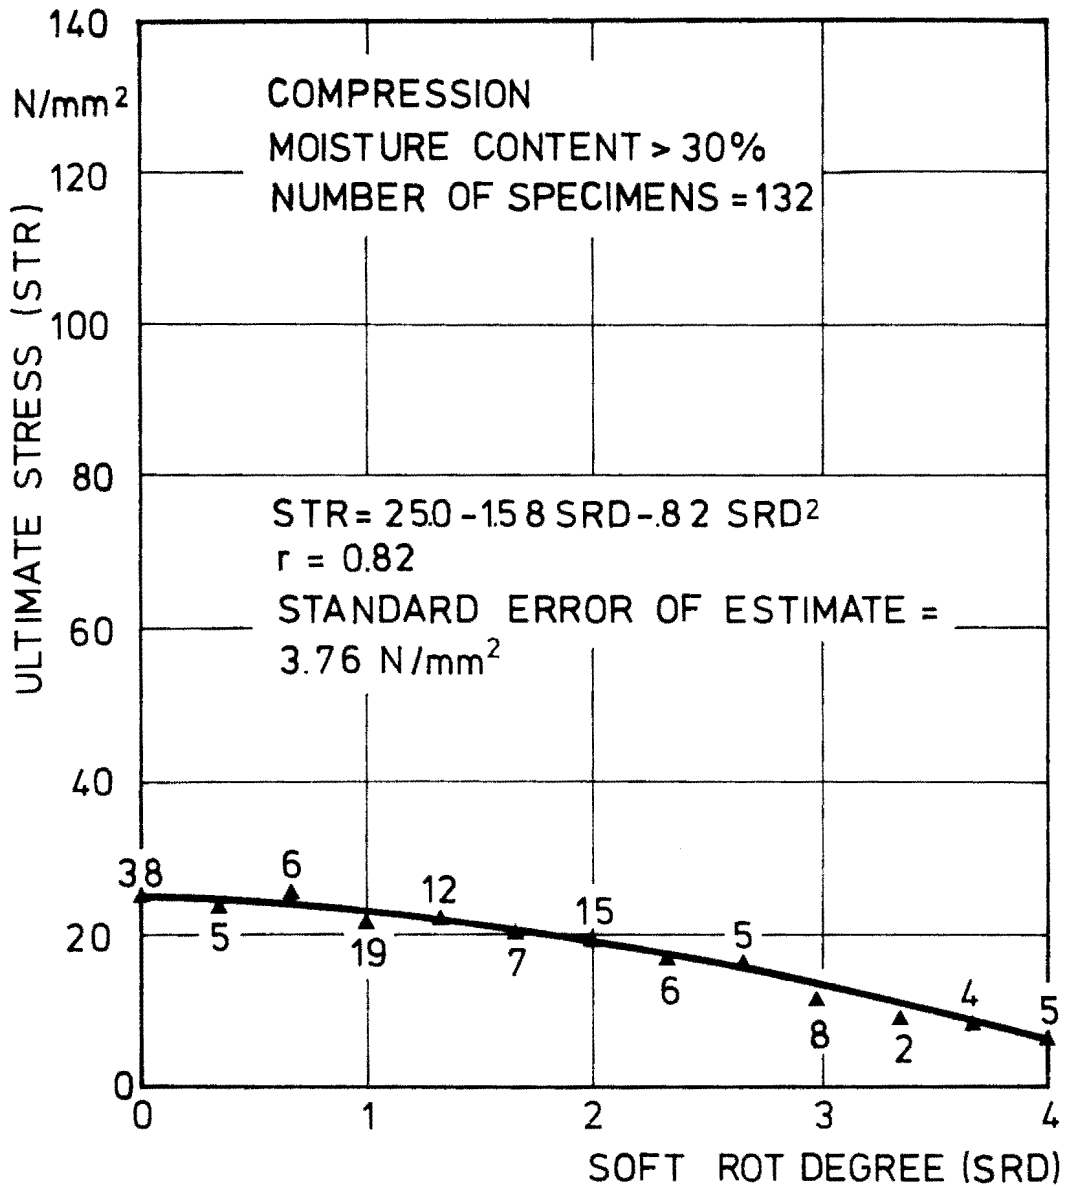
FIGURE 8.
REGRESSION OF SOFT ROT DEGREE ON ULTIMATE
COMPRESSION STRESS.

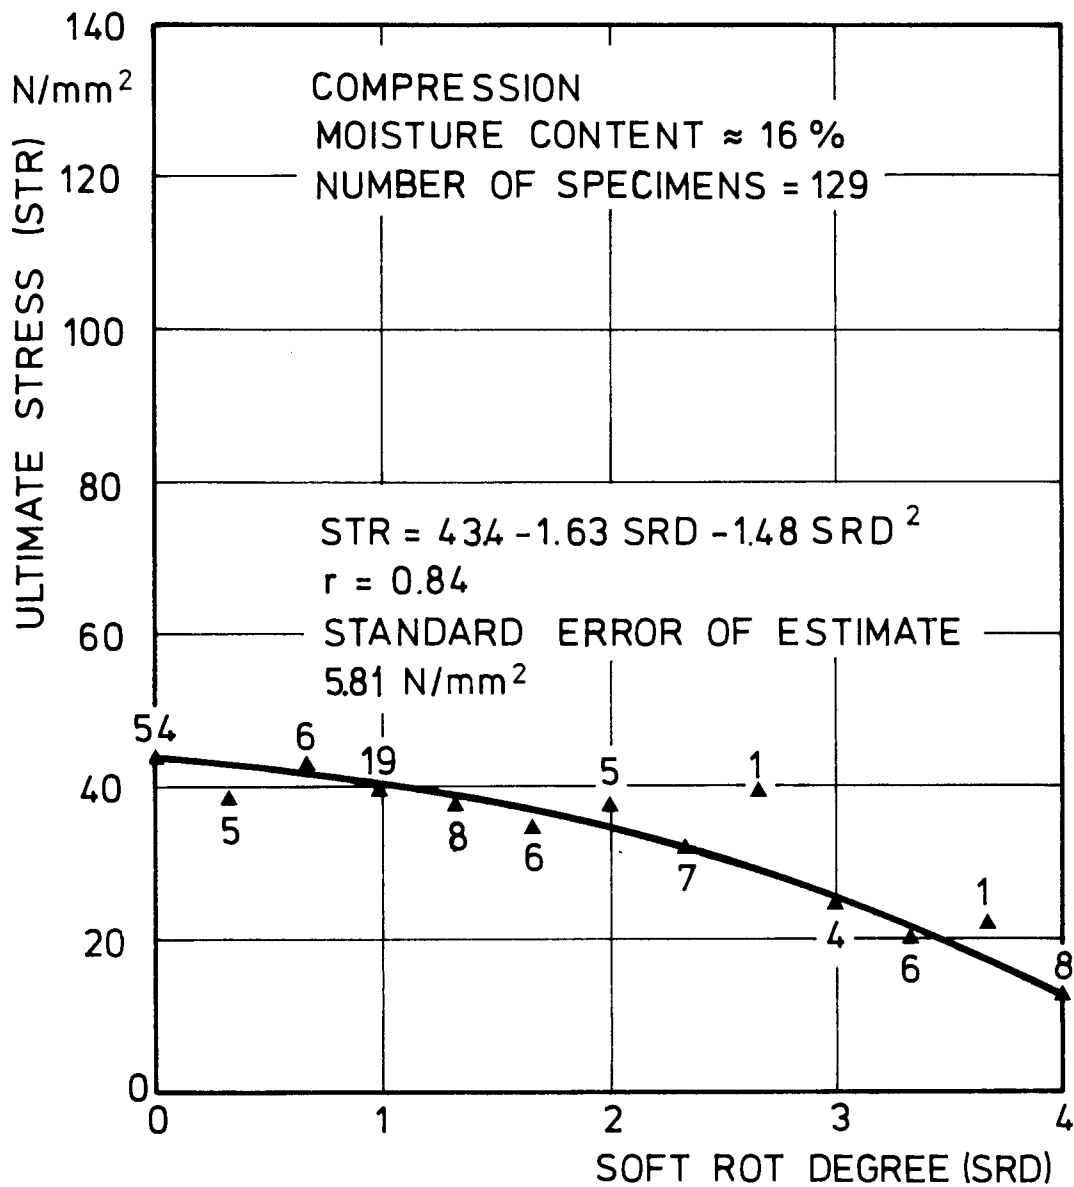
FIGURE 9.
REGRESSION OF SOFT ROT DEGREE ON ULTIMATE
COMPRESSION STRESS.

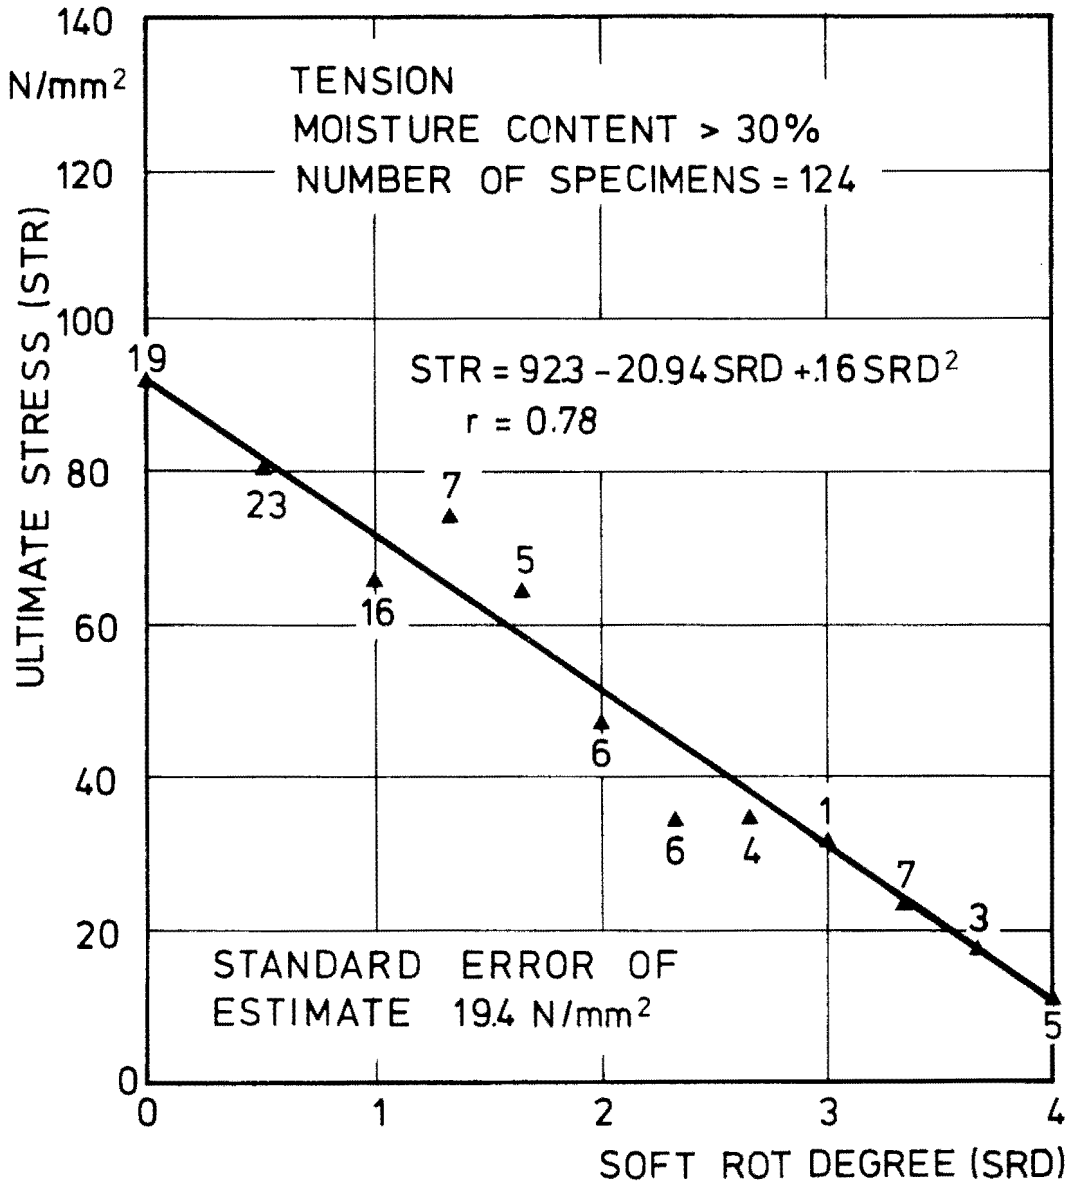
FIGURE 10.
REGRESSION OF SOFT ROT DEGREE ON ULTIMATE
TENSILE STRESS.

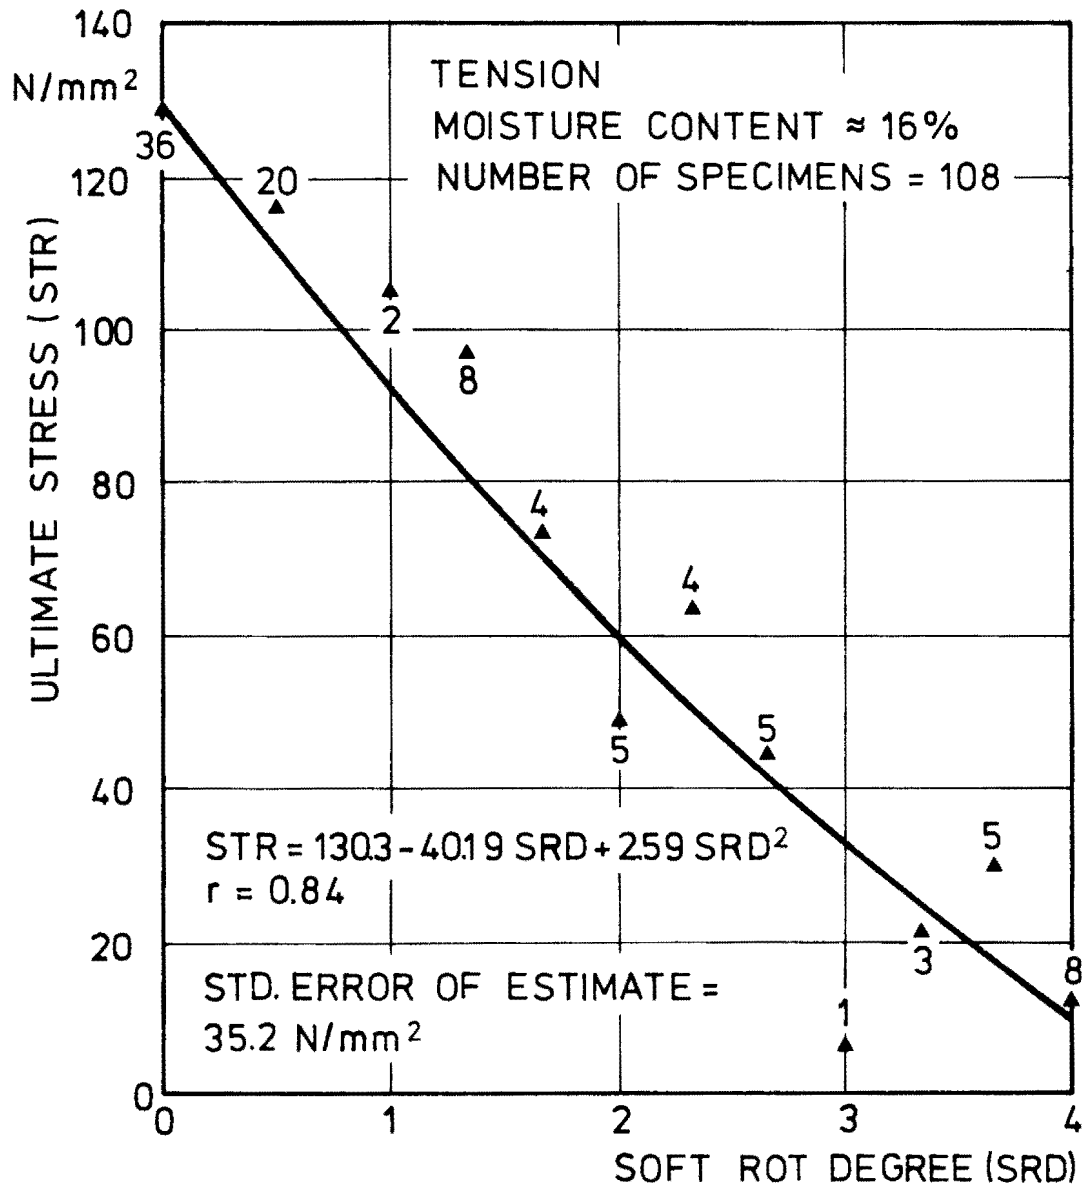
FIGURE 11.
REGRESSION OF SOFT ROT DEGREE ON ULTIMATE
TENSILE STRESS.

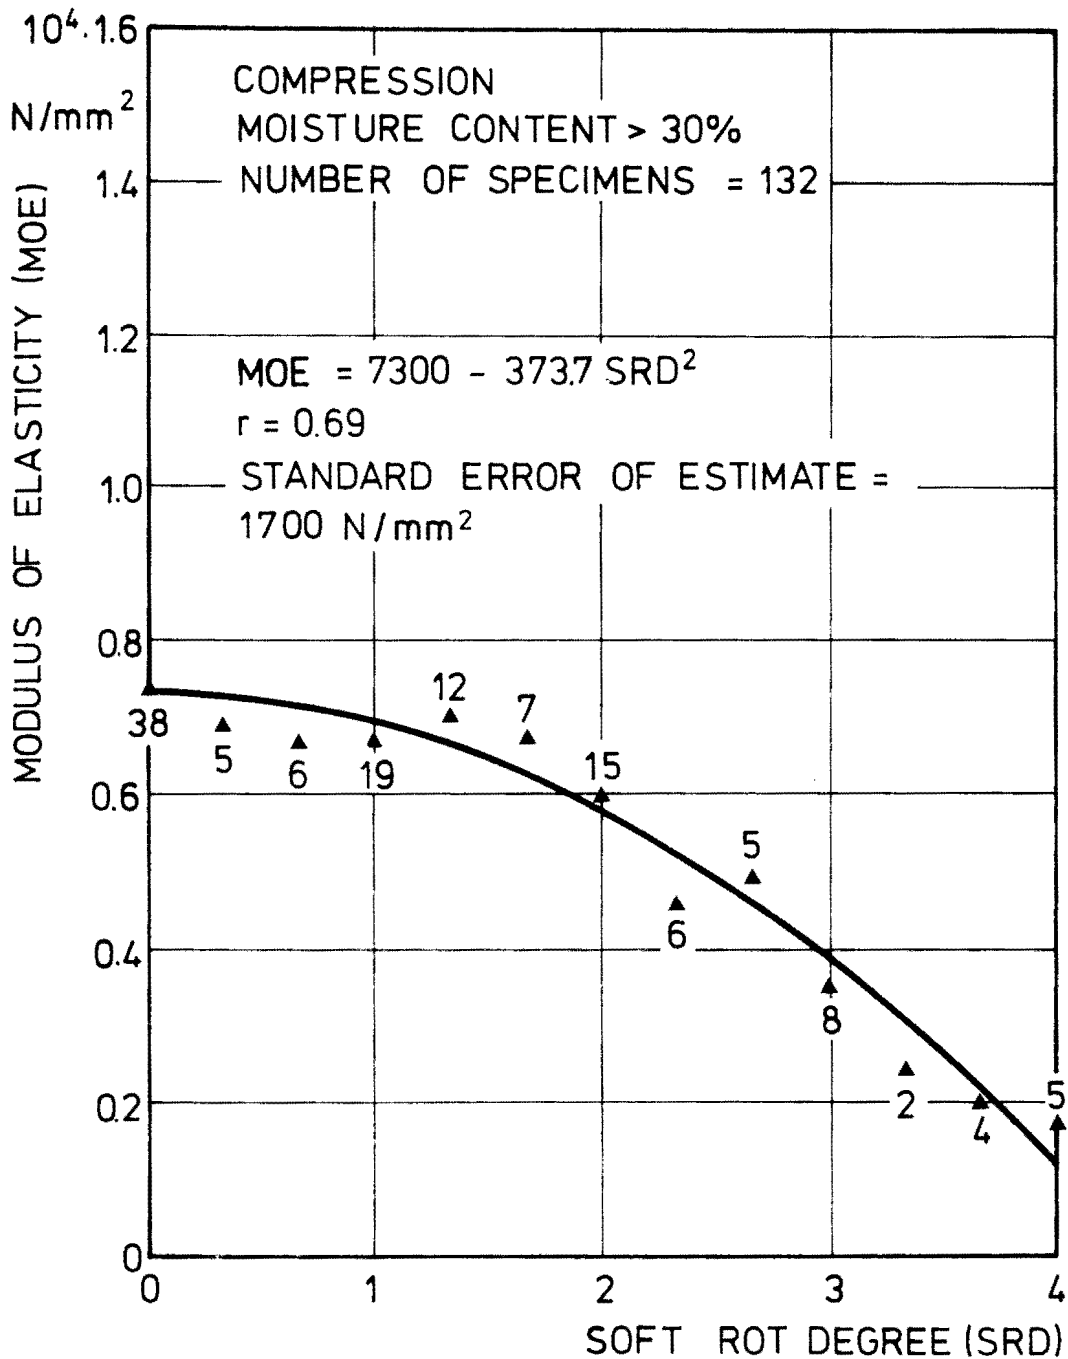
FIGURE 13.
 REGRESSION OF SOFT ROT DEGREE ON MODULUS
 OF ELASTICITY IN COMPRESSION.

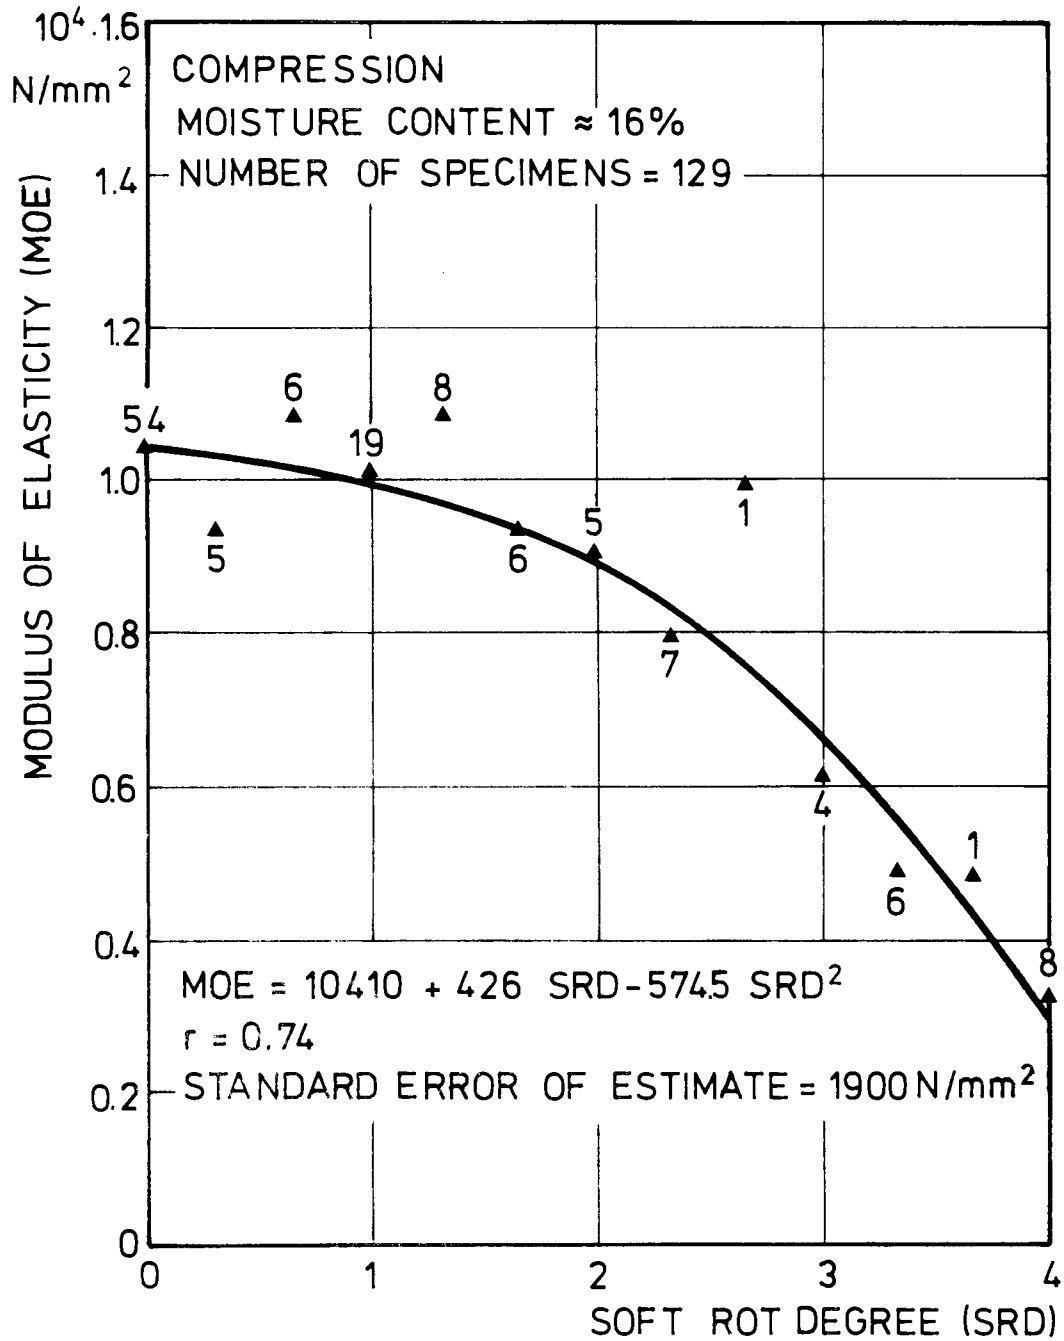
FIGURE 14.
 REGRESSION OF SOFT ROT DEGREE ON MODULUS
 OF ELASTICITY IN COMPRESSION.

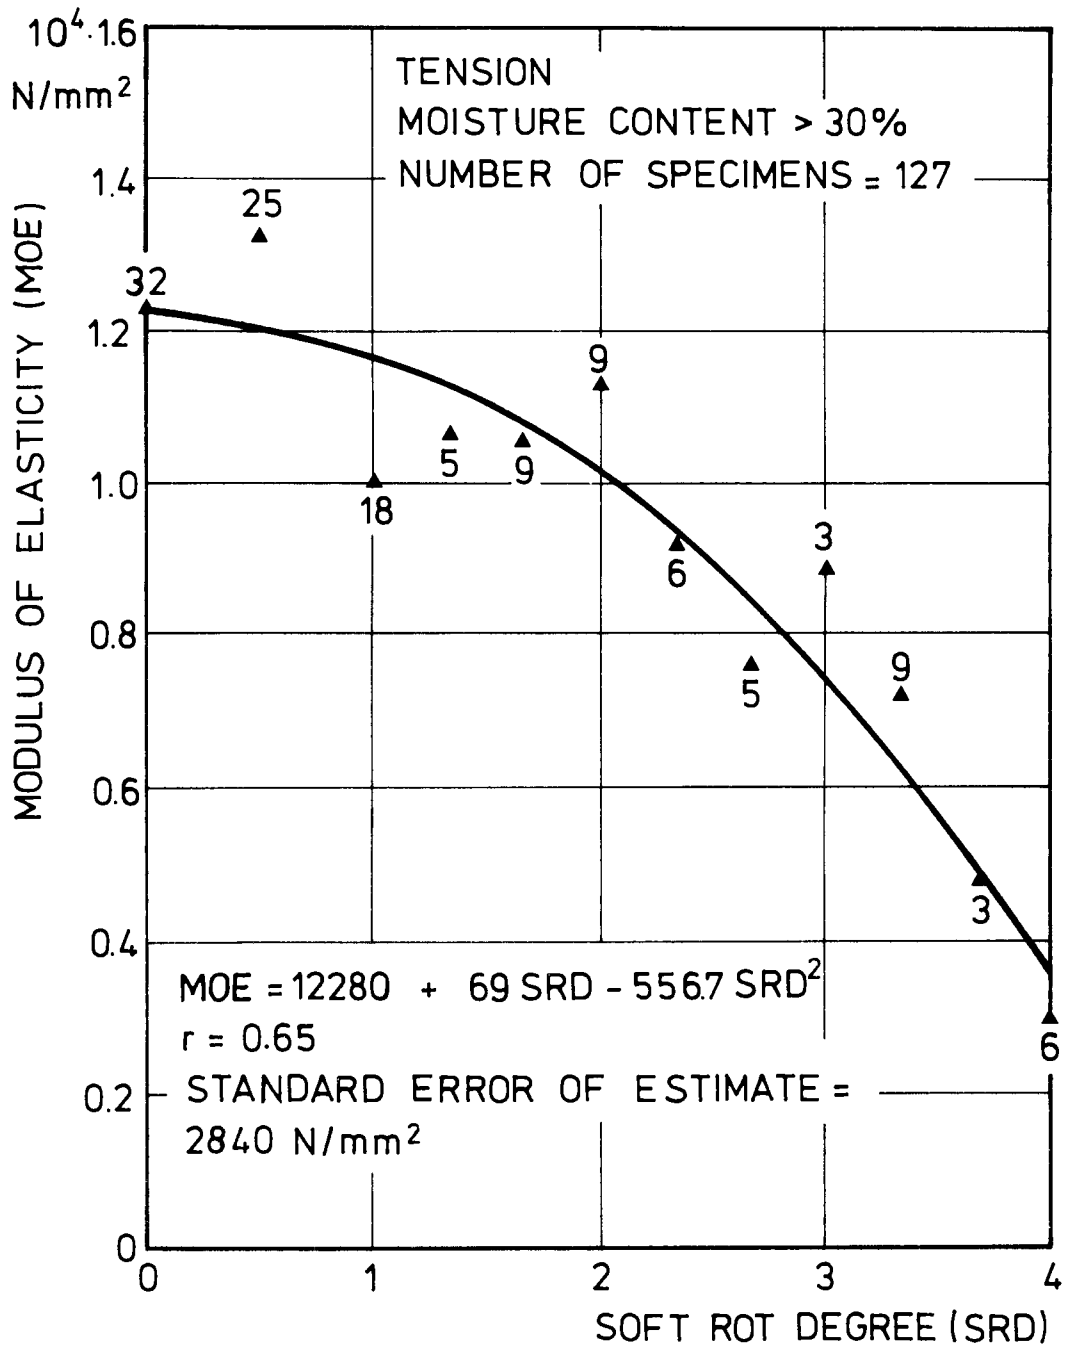
FIGURE 15.
REGRESSION OF SOFT ROT DEGREE ON MODULUS
OF ELASTICITY IN TENSION.

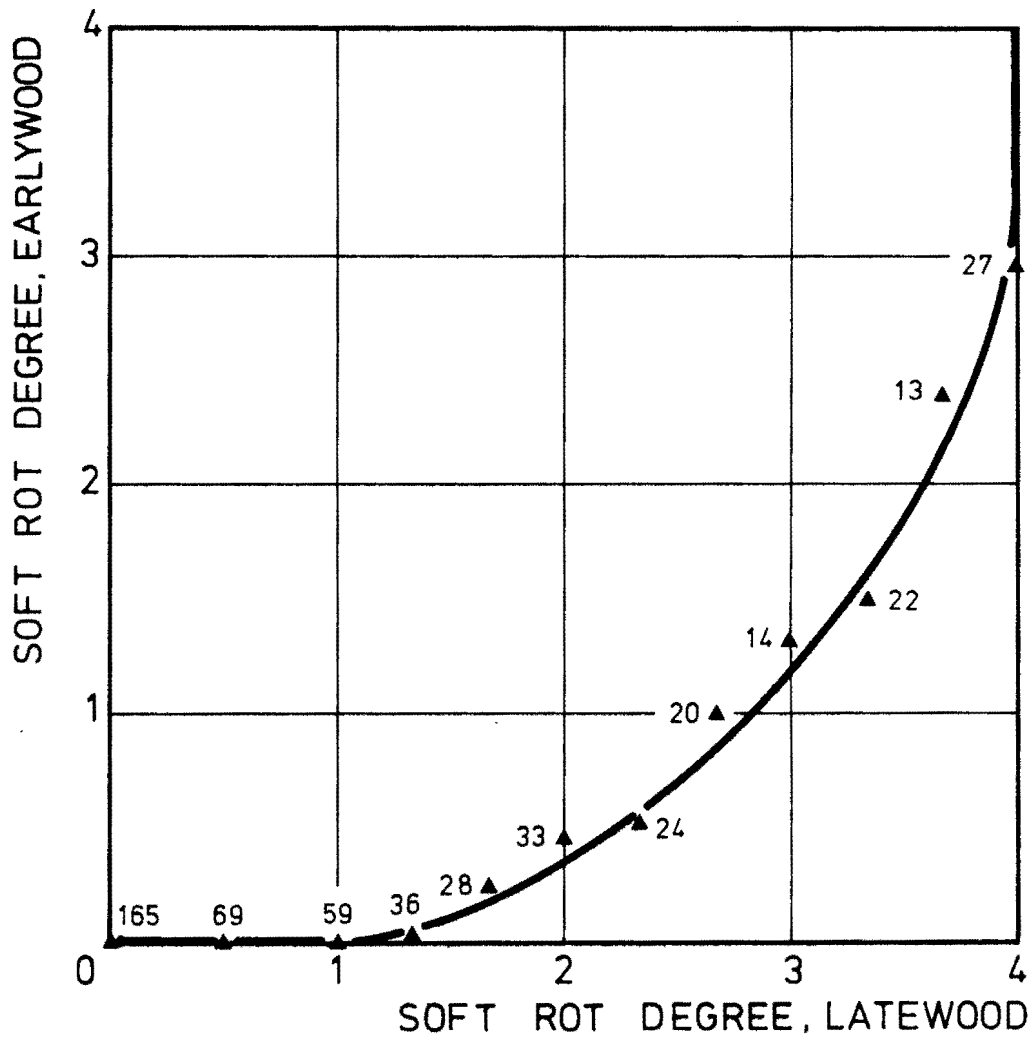
FIG.21

Diagram illustrating the preferential soft rot decay of latewood cells.

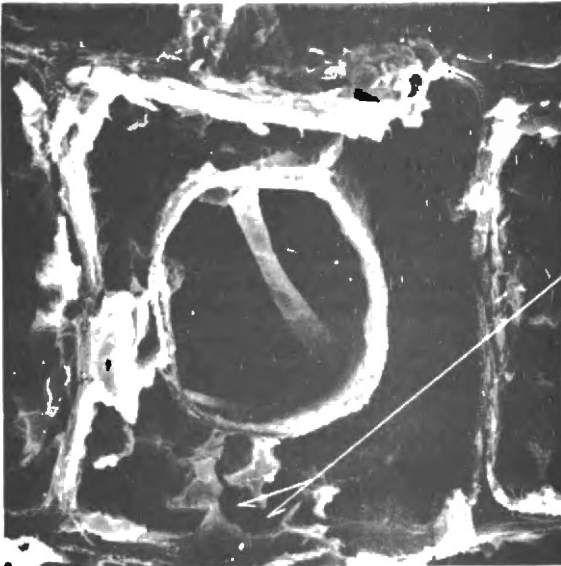
Heavily decayed latewood cells.

Note the few remaining cavities.

Note the shear failure of the S1 region, and note the S3 layer forming a hollow cylinder having very little structural contact with the rest of the wood substance.

FIGURE 24. Tensile failure of heavily decayed Scots pine latewood. Scanning micrographs.

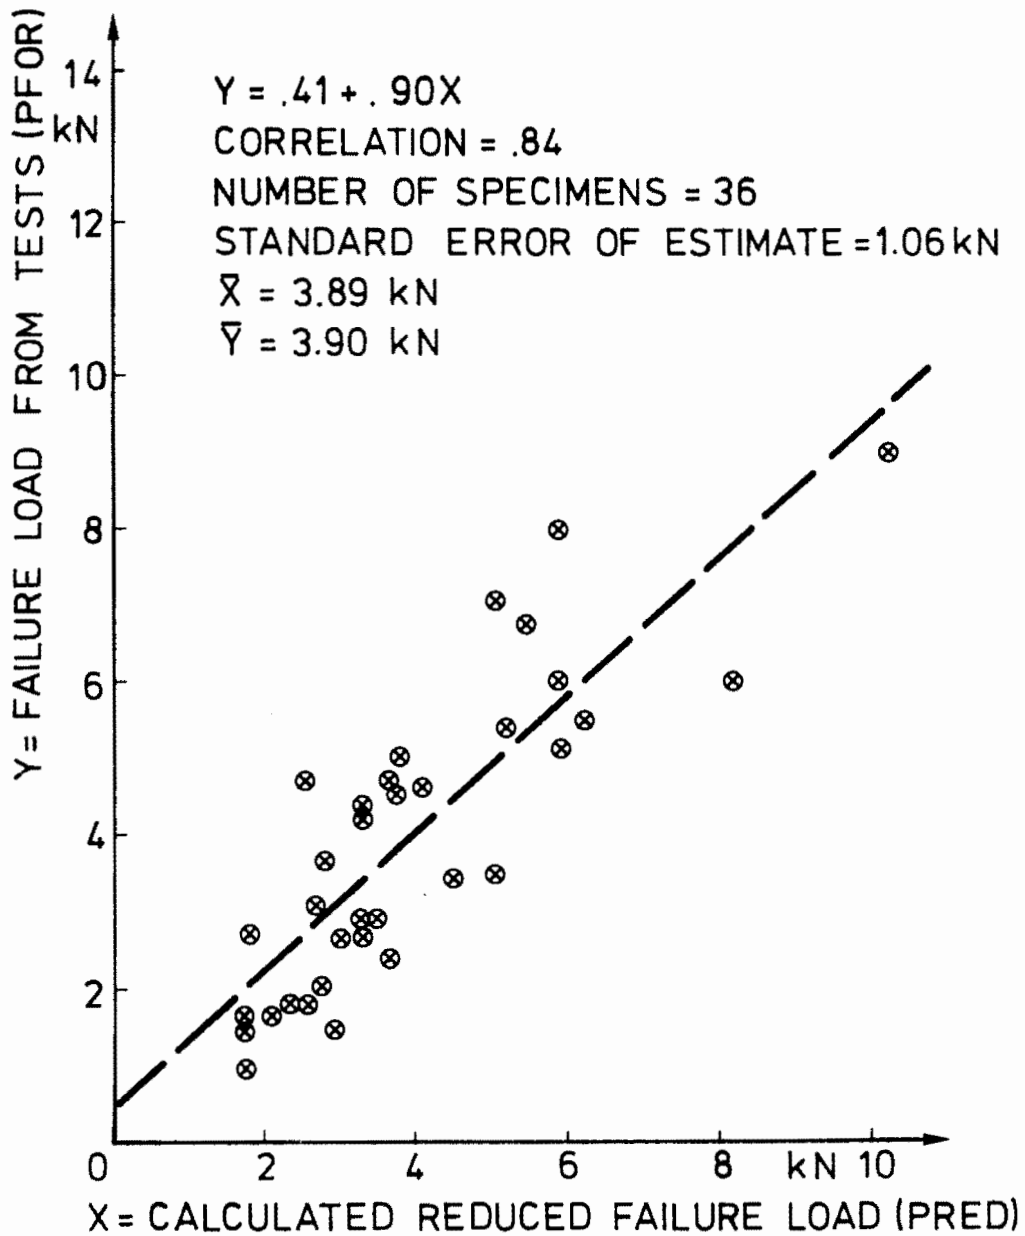
FIGURE 28
 REGRESSION OF CALCULATED REDUCED FAILURE
 LOAD ON FAILURE LOAD FROM TESTS.

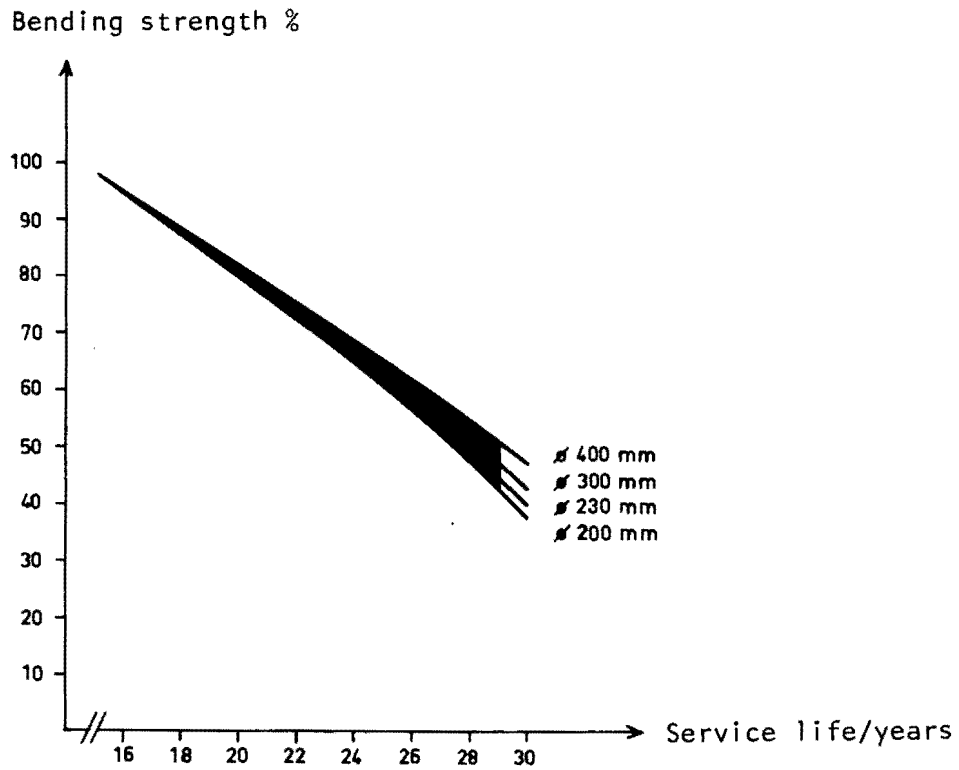
Fig 7. The bending strength of the poles as a function of service life. Following ground line diameters are represented: 200, 230, 300 and 400 mm.

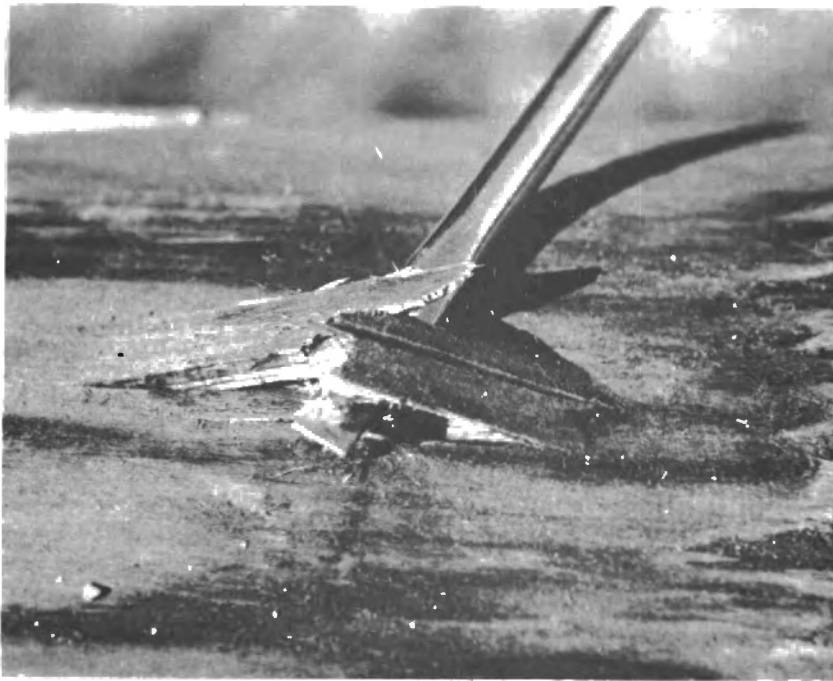
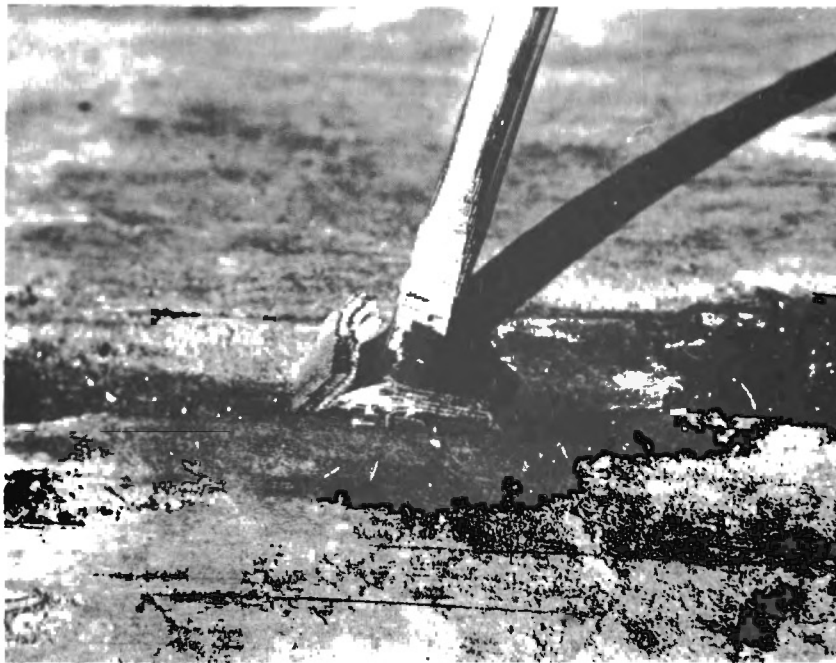
Fig 9. Typical fractures when using the "poking method".
A. sound wood B. soft rot attacked wood.
Photo Kai R Spangenberg

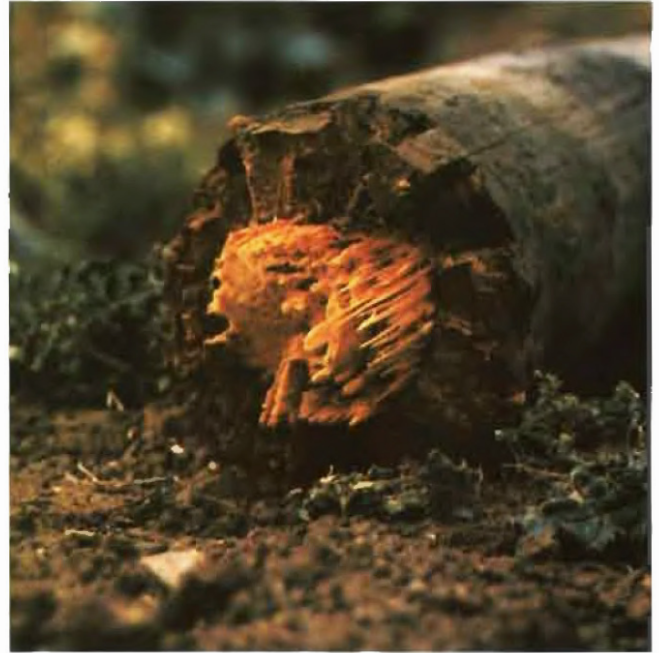
Fig 1.

Salt-treated pole from 1941. Strength tested in 1972. Calculated bending strength of sound pole: 6.8 kN. Residual strength at test: 2.4 kN. Note the typical soft rot fracture in the sapwood.

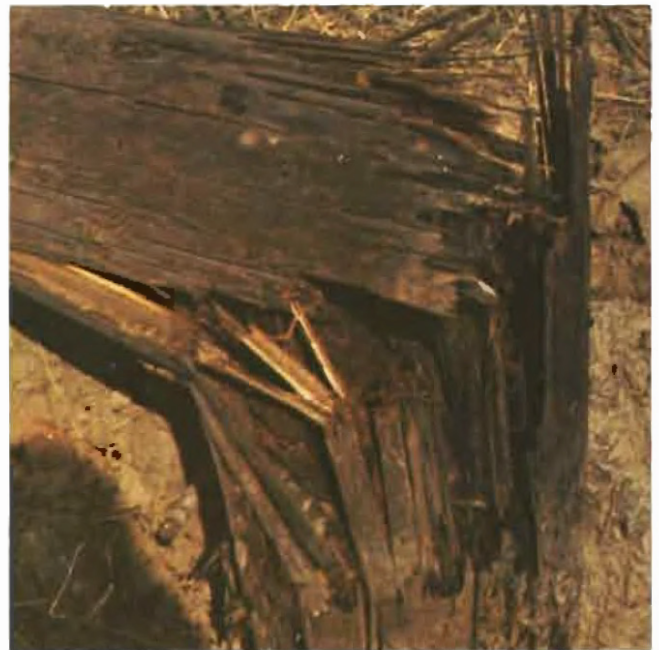
Fig 2.

Creosote-treated pole from 1938. Strength tested in 1974. Calculated bending strength for sound pole: 7.6 kN. Residual strength at test: 4.2 kN. Note the complicated and tough fracture, typical of creosoted poles.

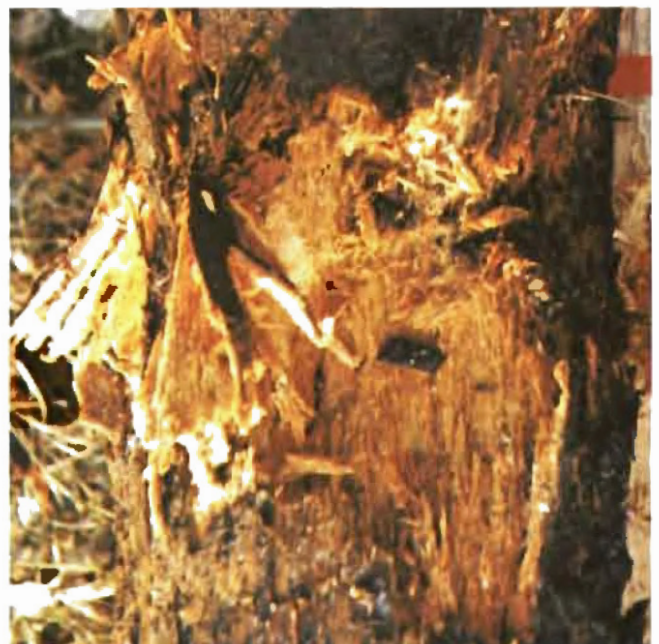
Fig 3.

Salt-treated pole from 1942 with heavy attack of "orange-decay". This pole was not strength tested. Note the characteristic "orange-decayed" sapwood under the outer crust.
